Manhole Inspection Summary

Manhole # S63G__021MH

Location Address: **5100 Mason Lord Dr.**

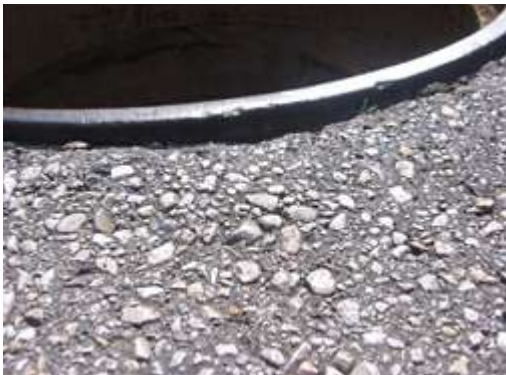
Defect 2

Rim above grade. Possible infiltration source.

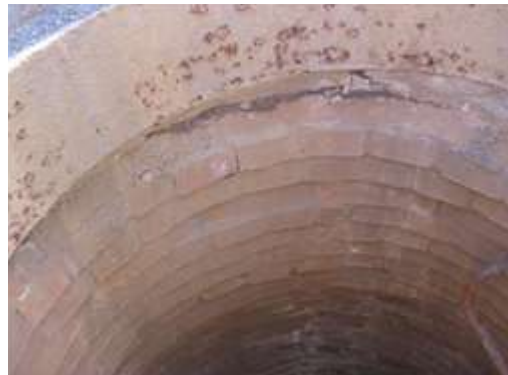
Defect 3

Infiltration at frame seal.

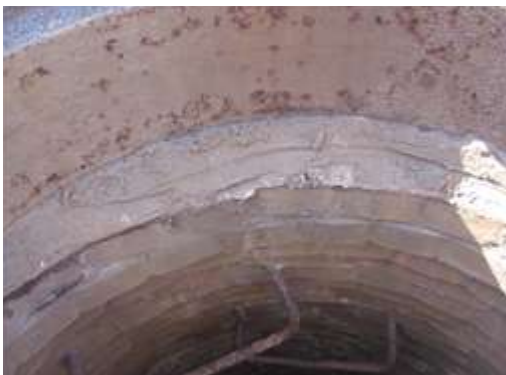
Defect 1

Frame Offset: **1** (in.) Condition: ☒ Sound ☐ Cracked ☐ Leaks

Frame offset

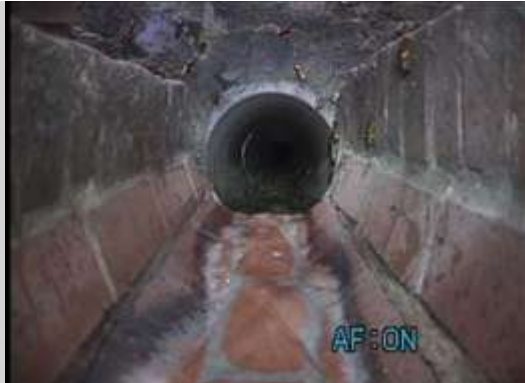
12 O'Clock Outflow

8 in. Circular Gravity Sewer
Pipe Out @ 12 O'Clock

Pipe Height: **8.4** (in.) Rod and Bar (Angled)
Pipe Material: **Clay** ☐ Pipe Lined
Invert Depth: **11.42** (ft.) Flow Characteristics: **Fast**
Deposits: ☒ None ☐ Mud ☐ Sludge ☐ Debris ☐ Grease
Silt Depth: (in.) Deposits Extent:
Infiltration: **None** Pipe Seal Cond: **Sound**

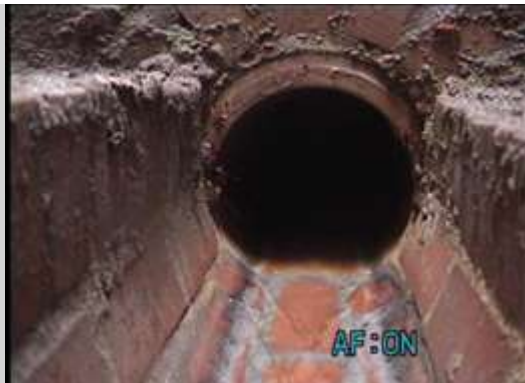
6 O'Clock Inflow

8 in. Circular Gravity Sewer
Pipe In @ 6 O'Clock

Pipe Height: **8.4** (in.) Rod and Bar (Angled)
Pipe Material: **Clay** ☐ Pipe Lined
Invert Depth: **11.25** (ft.) Flow Characteristics: **Fast**
Deposits: ☒ None ☐ Mud ☐ Sludge ☐ Debris ☐ Grease
Silt Depth: (in.) Deposits Extent:
Infiltration: **None** Pipe Seal Cond: **Sound**
